# Winder Trimming

## a case study

*Today, paper trim on the operating floor is no longer an issue at Weyerhaeuser's board mill in Sturgeon Falls.*

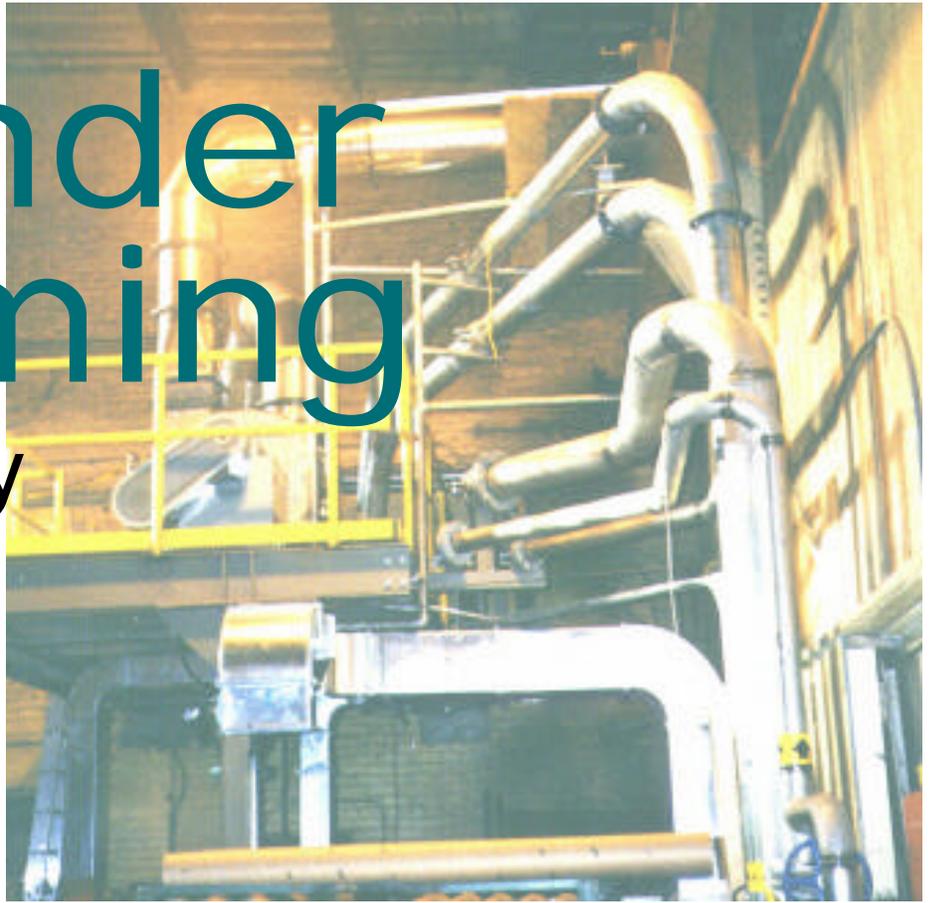
**W**eyerhaeuser's board mill in Sturgeon Falls, Ontario produces 95,000 mt/y of corrugated medium. The mill operates one paper board machine and utilizes an in-line 151 inch wide Cameron winder, with trimming stations on the tending and drive side.

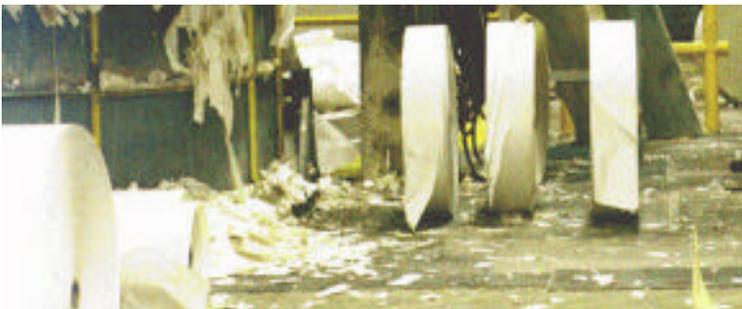
**In many paper mill machine rooms, paper trim on the operating floor can often create both safety and housekeeping concerns.**

**THE PROBLEM:** Paper trim from the winding operation, was pneumatically conveyed via a chopper fan and ducting and re-introduced to the dry end pulper. The pulper accepted trim and the accompanying motive air from two sources - the winder and a web welder. The pulper was not equipped with an exhaust system and consequently some of the moisture laden paper fragments from the chopping operation would continually exit the operating floor pulper opening with the excess air. The wet paper fragments would settle on the operating floor creating concern for safety as they introduced a slipping hazard for the operating crew.

The presence of the paper fragments on the operating floor also became a housekeeping issue.

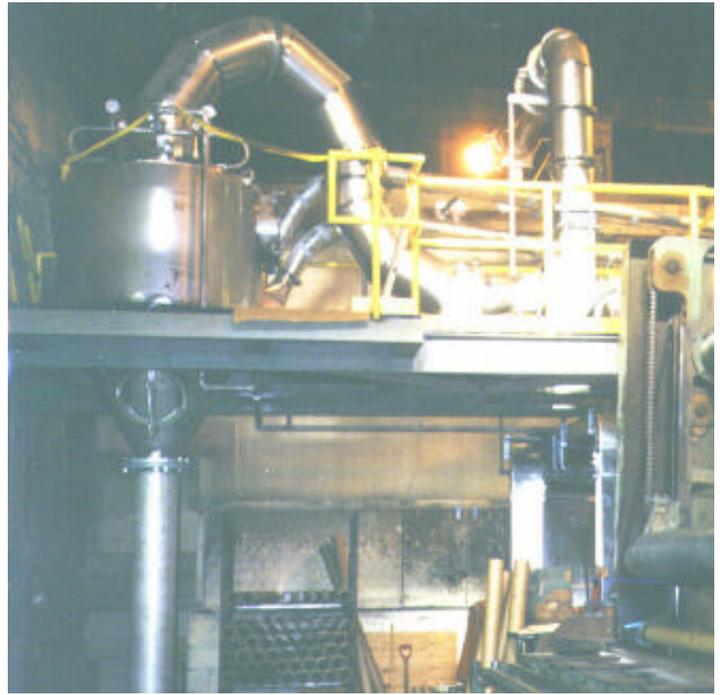
The **BERVAC Vacuum Trim Handling System** operates on a principle where the paper trims are conveyed unbroken in ducts under low vacuum from a winder or the like to a pulper. The trim is separated from the air stream in a separator, using stock or white water. The separator is connected to the pulper by means of a discharge pipe. This connection to the pulper is made below the pulper stock level, which forms an air lock in the discharge pipe. No mechanical rotary feeder or similar trim feed equipment is required. The stock and white water used to flush the paper entering the separator down into the pulper is typically taken from the pulper circulation and supply lines. The air flow required for trim conveyance is produced with a standard centrifugal fan. The fan exhaust air is reintroduced back into the machine room.

Space limitations were overcome by placing the separator and fan on a new mezzanine on the operating floor on the winder drive side.

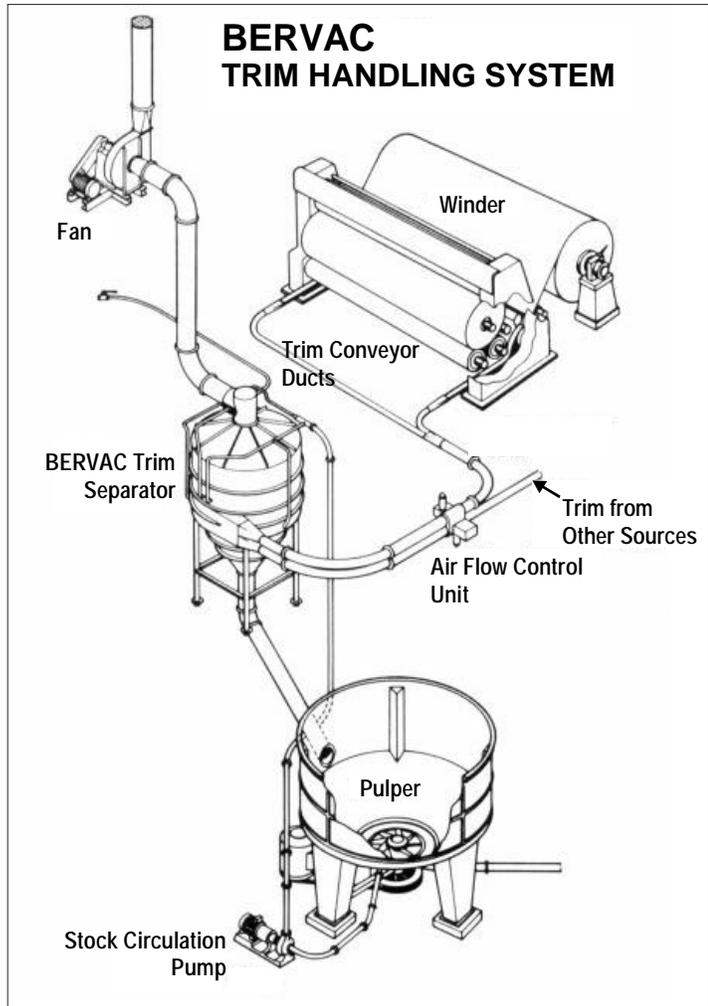
*As a result of its simple operating principle, the BERVAC trim handling system is a very reliable system. Besides the standard centrifugal exhaust fan, there are no moving parts.*

As a result of this simple operating principle, the BERVAC trim handling system is a very reliable system.. Besides the standard design centrifugal exhaust fan, there are no moving parts.

A number of winders may be served by a single BERVAC system. The BERVAC trim conveying system is suitable for the handling of practically all types of paper broke which allow pneumatic transport.

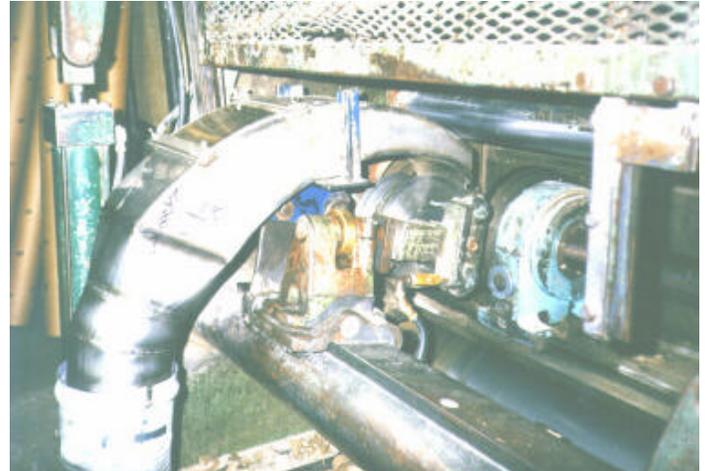
**New trim chutes were installed because air flow rates were considerably lower than the existing system.**

- Space limitations resulted in placing the separator and fan on a new mezzanine on the operating floor on the winder drive side, resulting in additional costs.
- New trim chutes were required because air flow rates were considerably lower than the existing system, resulting in additional costs.
